Disaster Response Disaster Response

*A firsthand account from the most dangerous workplace in the U.S.
By Jeffrey W. Vincoli, Norman H. Black and Stewart C. Burkhammer*

On Sept. 12, 2001, a small group of SH&E professionals from Bechtel Group Inc., led by Stewart Burkhammer, a professional member of ASSE's National Capital Chapter, arrived in New York City to assist the city and state of New York in the emergency recovery effort after the terrorist attacks on the World Trade Center. The sights and experiences of the days and weeks that followed are described here in order to provide fellow SH&E professionals a brief account of the extraordinary challenges encountered at Ground Zero.

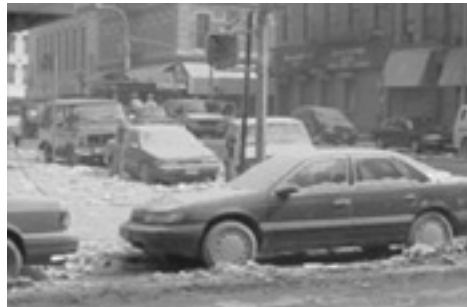
Photo 1 (above): Dust covered everything at and around Ground Zero.

Dust was one of the first things the group noticed. A fine, gray dust, later determined to be mostly pulverized concrete covered everything at the 16-acre disaster site (Table 1). More than 160 buildings in lower Manhattan were cloaked in the powder and would need to be cleaned. Dust was settling everywhere—on the streets, parked vehicles, buildings, lightposts, fences (Photo 1). A tremendous amount of paper was scattered across the site as well—files, notes, pages from desk calendars, photographs, unopened mail, legal documents and myriad other papers common to an office environment. Papers and dust even blanketed a small cemetery located directly across the street from the site. There were also shoes of all types, styles and sizes scattered everywhere.

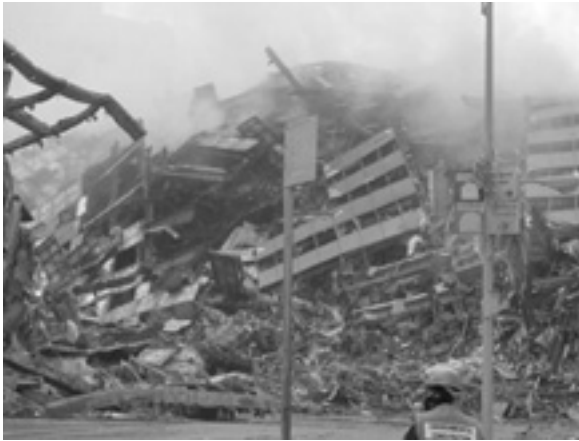
Photo 2 (above, left): WTC-7, a 47-story building destroyed in the attacks.

We first walked past the ruins of WTC Building 7 (Photo 2)—a 47-story office building before it collapsed at 5:20 pm on Sept. 11. We then headed toward the corner of Church and Liberty streets. From here, the full impact of the attack was clear. Where WTC Building 4 once stood laid the remains of Tower 2 (the South Tower, WTC-2), which collapsed at 10:00 am on Sept. 11, raining tons of steel, glass and concrete debris onto the southeast corner of Building 4 (Photo 3). All that remained standing of Tower 2 was its lower curtain wall, which was dubbed “the coliseum” because of its odd appearance (Photo 4).

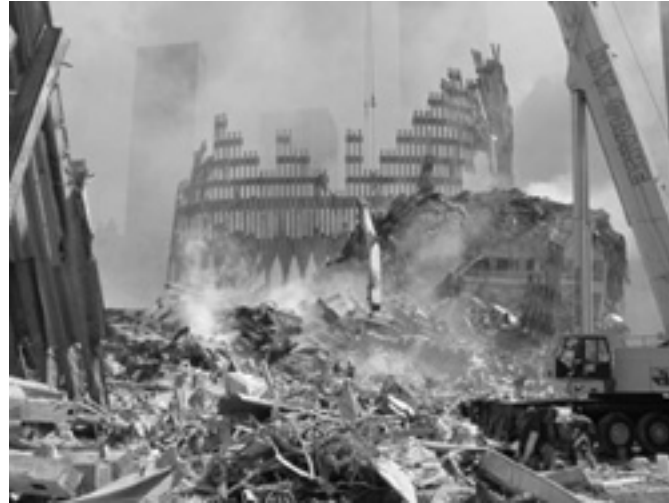
Photo 3 (right): The remains of Tower 2 fell on the southeast corner of WTC-4, which can be seen in the background.

The area where WTC-2 fell became—and would remain—a major focus for search-and-rescue personnel. Even though WTC-2 was the second building to be attacked, it was the first to collapse. An orderly evacuation was in progress when the building crumbled. Many firefighters were climbing the stairwells and were killed when the building fell, as were a large number of WTC-2 workers. Since Tower 1 did not collapse for another 30 minutes, many potential victims had time to escape that building.

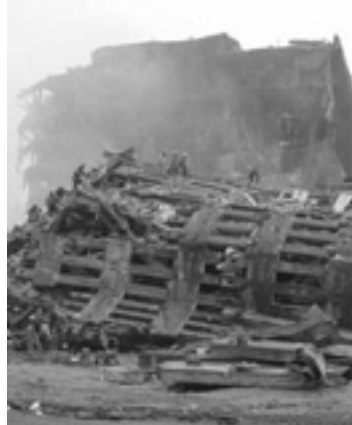
Photo 4 (above, right): The curtain wall of Tower 2, which was referred to as “the coliseum.”

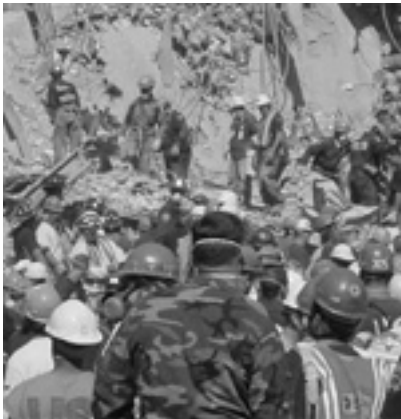
Photo 5 (above left): The site was flooded with people trying to assist, many wearing no or improper PPE.

Although the site was extremely dangerous, most volunteers wore no personal protective equipment (PPE). Some wore shorts, sneakers and sleeveless shirts. Others wore some combination/variety of protective equipment—hard hats, dust masks, surgical masks and even handkerchiefs used as respiratory protection. Some wore safety goggles and even faceshields, while others wore no eye protection. This equipment was often inadequate, however. The debris pile was unstable and rife with hazards, including shards of glass, erupting fires, collapsing debris, slippery surfaces, and hundreds of rebar “spears” projecting at all angles from the pile. Heavy equipment (dump trucks, excavators and bulldozers) moved about rapidly, often with no apparent regard for the massive number of pedestrians populating the site. As safety professionals, the scene was an

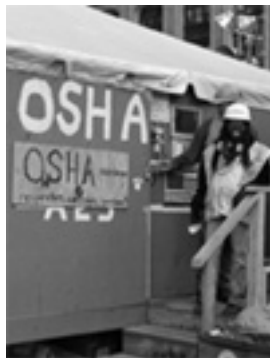
Photo 6 (above, middle): One of OSHA's PPE distribution centers and respirator fit test stations near the disaster site.

The Salvation Army, American Red Cross and other groups provided enclosed eating stations and washing facilities for workers. NIOSH, and later OSHA, operated respirator fit testing stations and distributed thousands of respirators to workers (Photo 6). SH&E team members also helped workers with respiratory protection (Photo 7). Triage stations and first-aid facilities were relocated to tents and other protected structures (such as commandeered restaurants, exercise facilities and other establishments located near Ground Zero).

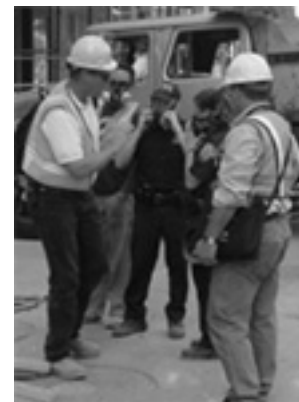
Photo 7 (above right): Norm Black (left) helps a New York City police officer fit her respirator.

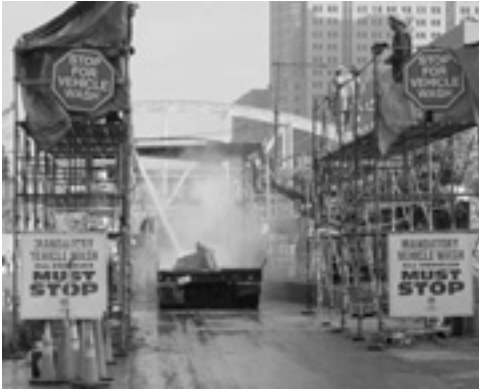
Photo 9 (right): Laborers clean 1 Liberty Plaza. At the time the work was being performed, consistency of the dust was not known.

In the early stages of the recovery effort, the composition of the smoke and dust coming from the pile was undetermined. A dust suppression plan was implemented to ensure adequate protection of workers and the surrounding neighborhoods as debris was trucked offsite. Vehicle washing stands were erected at perimeter locations, and no vehicle was allowed offsite without first being washed down properly (Photo 8). Task-specific dust-suppression methods were implemented as required—such as to clean peripheral buildings in preparation for reoccupation (Photo 9). This included use of required PPE and specific clean-up techniques (watering, double-bagging, HEPA vacuuming, etc.) to minimize the amount of dust generated. While the use of water created some initial concerns regarding discharge, the benefit of reducing the risk of human exposure/contamination potential took precedence.

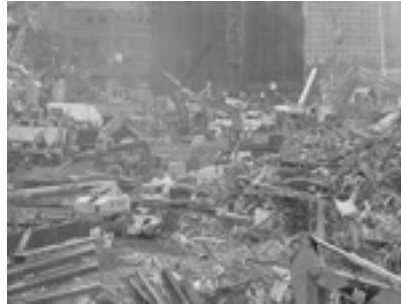
Photo 10 (below, right): A massive amount of heavy equipment was mobilized to assist in the recovery effort. This photo shows only the southwest corner of the 16-acre site.

The tremendous amount of heavy equipment used at Ground Zero created many opportunities for serious accidents (Photo 10). More than 30 crawler cranes (up to 1,000 ton in capacity), several dozen

excavators, scores of backhoes and dozers, hundreds of trucks and many other types of equipment moved about the site at a hurried pace 24/7. The team's recommendations to use spotters, back-up alarms, properly caged operator cabs, clear zones and related standard operating procedures prevented several accidents.

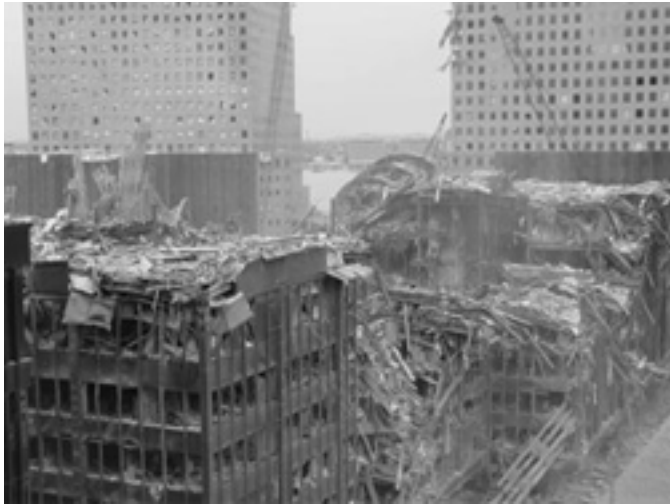
Photo 11 (top left): WTC Building 6 (U.S. Customs) viewed from the roof of a federal building.

- WTC Building 6 housed several federal agencies, primarily U.S. Customs (Photo 11). The third floor—now largely inaccessible—contained a firing range. More than 1.2 million rounds of ammunition were stored on this level, as was a vault used to store other explosives and weapons. A seizure vault was also on the third floor; it contained evidence (such as drugs, cash and evidence files) seized during Customs operations. Final status: At great personal risk, Customs officials, the FBI and contractor representatives located and removed the criminal evidence from Building 6 during the fourth week of the effort. The ammunition was finally located on Oct. 24, 2001, melted together into large “bullet balls” that were extremely dangerous to handle and dispose of properly (Photo 12). At one point, a discharge of a bullet, due to the immense heat in the area, caused a shrapnel wound to the face of one worker.

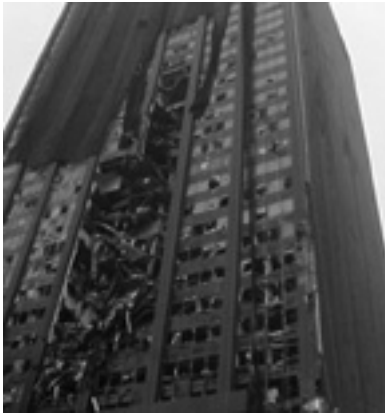
Photo 14 (top): The north face of 130 Liberty St. The broken windows were eventually covered completely with protective, flame-retardant netting.

- Four or five days following the attack, another disturbing element developed at the disaster site. The smell of decay was overwhelming, raising concerns about infectious disease control. Despite the NYC Dept. of Health's strict directives regarding the handling of human remains, several days of the inescapable odor only added to the mounting difficulties of the work.
- Glass from the many thousands of windows in the still-standing buildings that surrounded Ground Zero was broken; with the slightest wind or vibration, it showered down onto the rescue site. Because it took days for these buildings to be properly draped with protective netting (many stood more than 50 stories high), personnel faced a constant threat when working near these buildings (Photo 14).

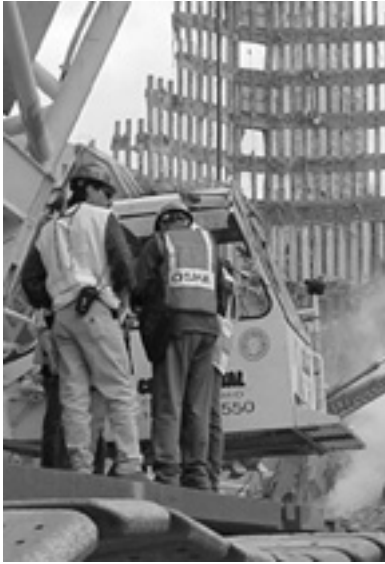
Photo 15: OSHA and the SH&E team joined forces to conduct inspections and monitor Ground Zero work activities.
